# RESEARCH MEMORANDUM

WIND-TUNNEL INVESTIGATION OF TRANSONIC AILERON FLUTTER

By Albert L. Erickson and Robert L. Mannes

June 9, 1949

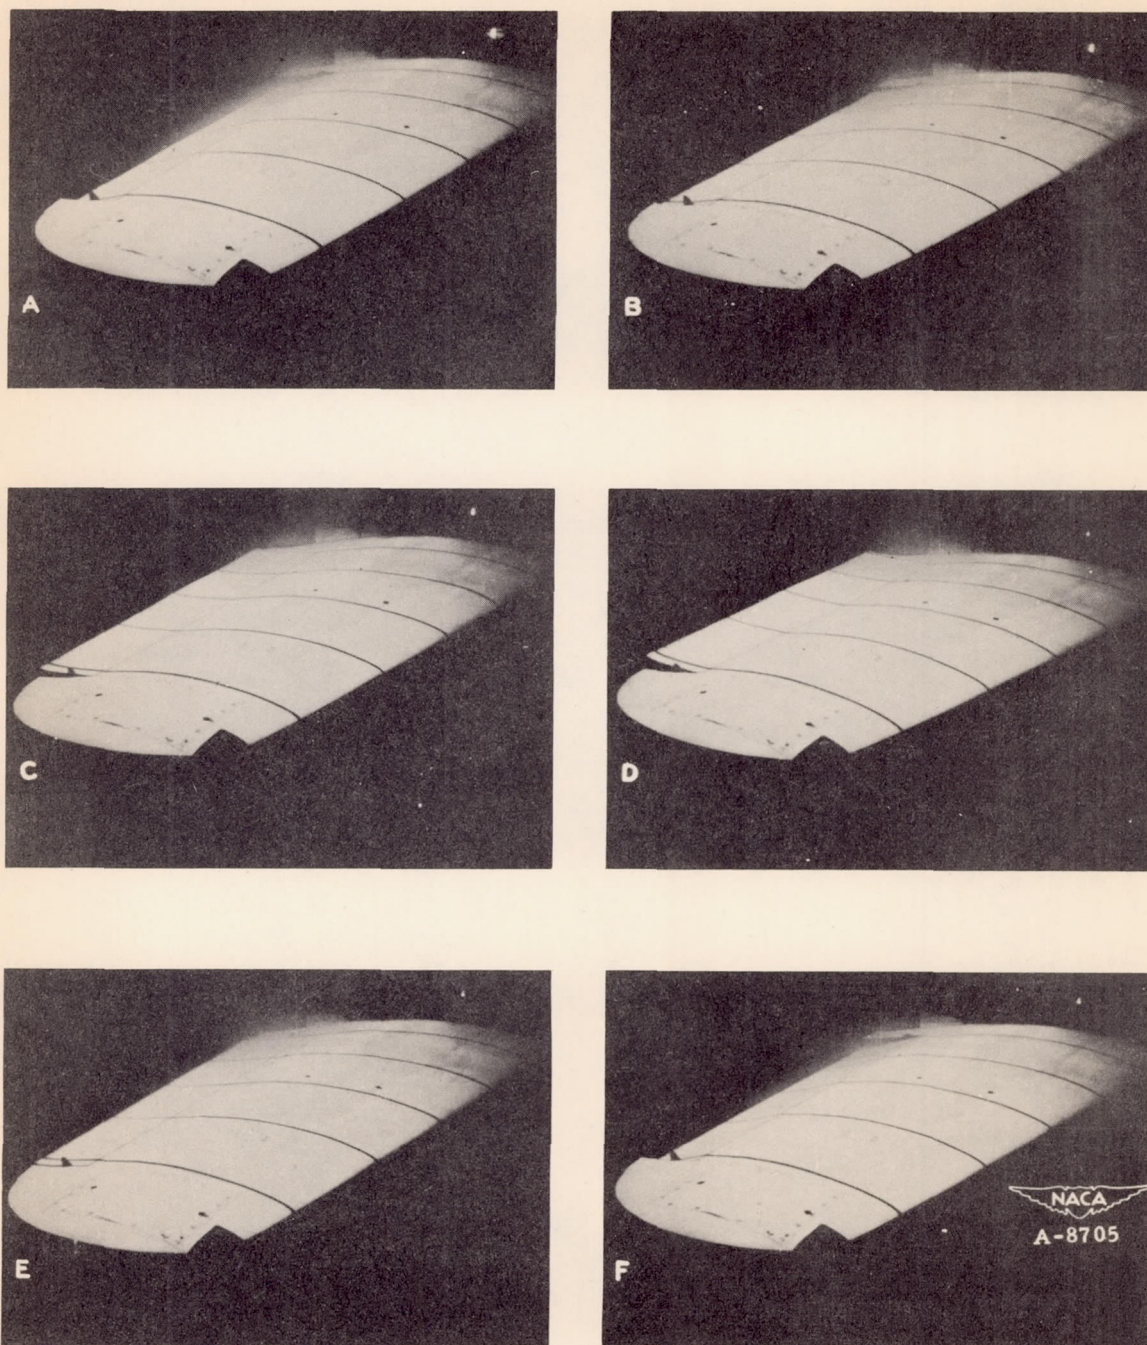
Figure 4.— Flutter of the aileron shown by successive pictures taken from a 128-frame-per-second motion picture.

Successive pictures of the wing and aileron during one cycle of flutter are shown in figure 4. These pictures are from a motion-picture record taken at 128 frames per second. The aileron displacement followed a sinusoidal pattern and led the wing torsional displacement by about  $60^\circ$ , as shown in figure 5. Later tests showed that the wing motion did not contribute to the basic flutter.

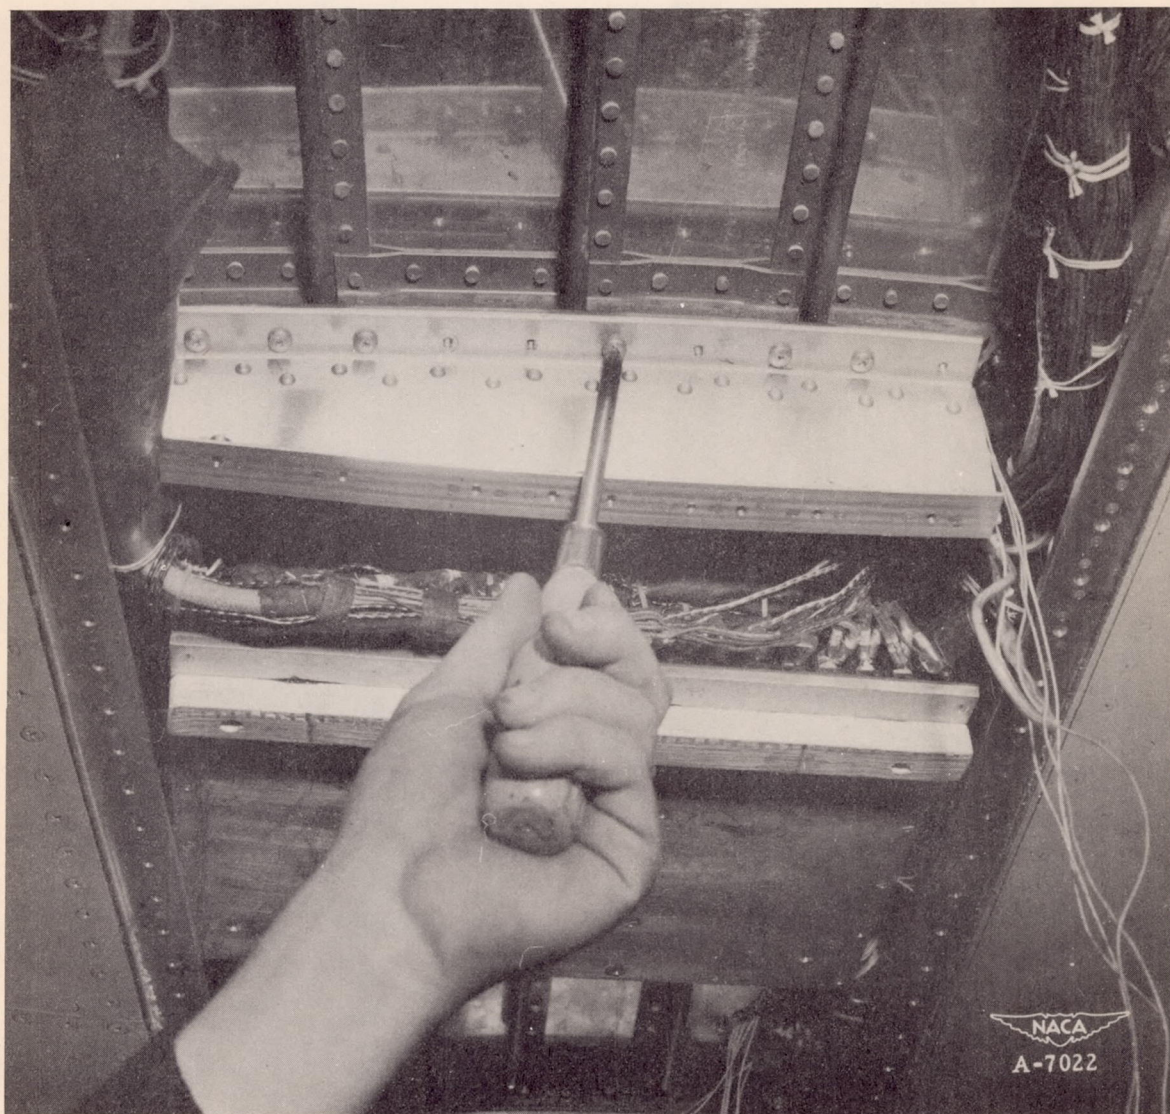
Figure 6.- One of the two special ribs installed at the partial-span wing.

A decrease in the torsional rigidity of the wing by the removal of two special ribs between the main beams (fig. 6) had no apparent effect on the flutter (table I, run 5 - cf. run 12).

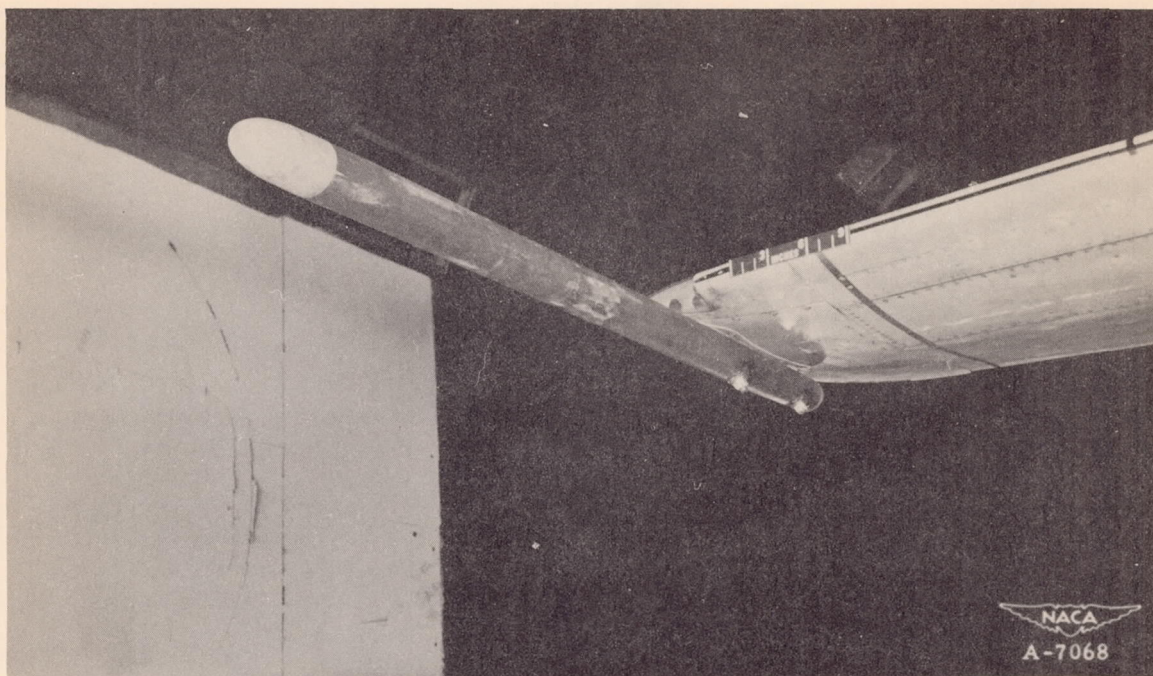
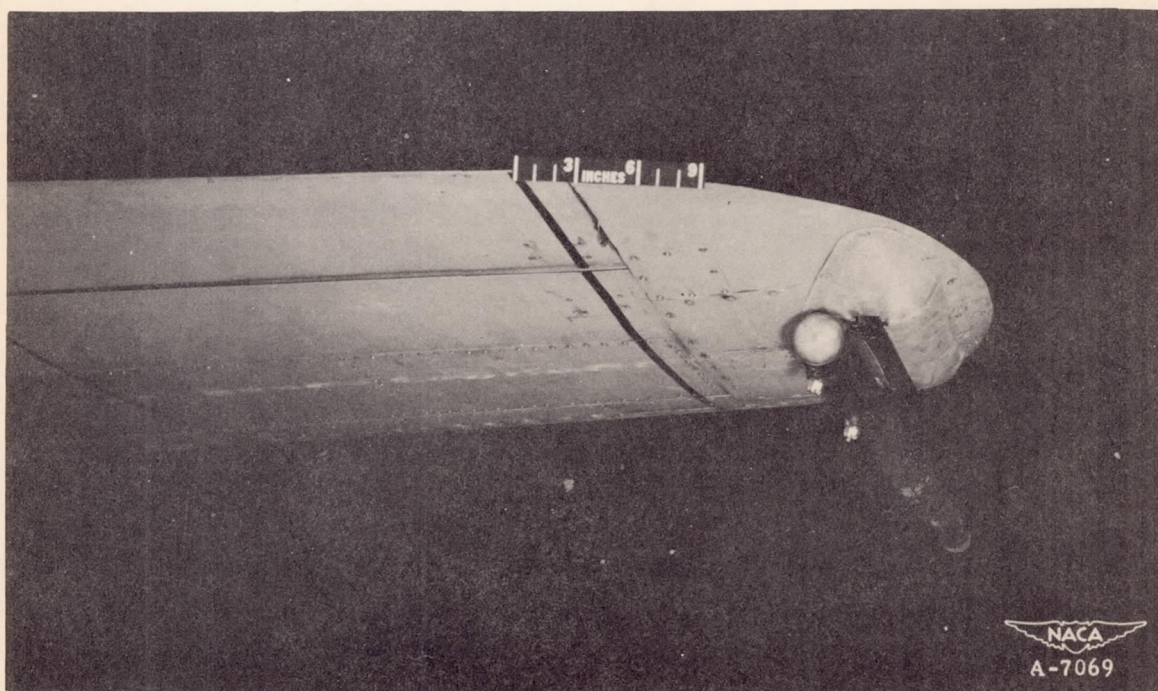
Figure 7.- Wing-tip boom mounted on the partial-span wing.

A boom was attached to the wing tip and extended forward into the air stream as shown in figure 7. This boom changed the natural frequency of the wing in bending from 15 to 13 cycles per second and in torsion from 51 to 26 cycles per second. It also caused a considerable change in the location of the apparent torsional nodes. (See fig. 8.) The locations of the apparent nodes were determined by the intersections of straight-line elements connecting the displacements indicated by the pickups. The torsional nodes indicated are approximately the true nodes. The apparent bending nodes, however, are of value only for comparative purposes. With the boom attached and the aileron fixed, the wing did not flutter. With the aileron free, the boom did not alter the aileron flutter (table I, runs 22 and 22A).

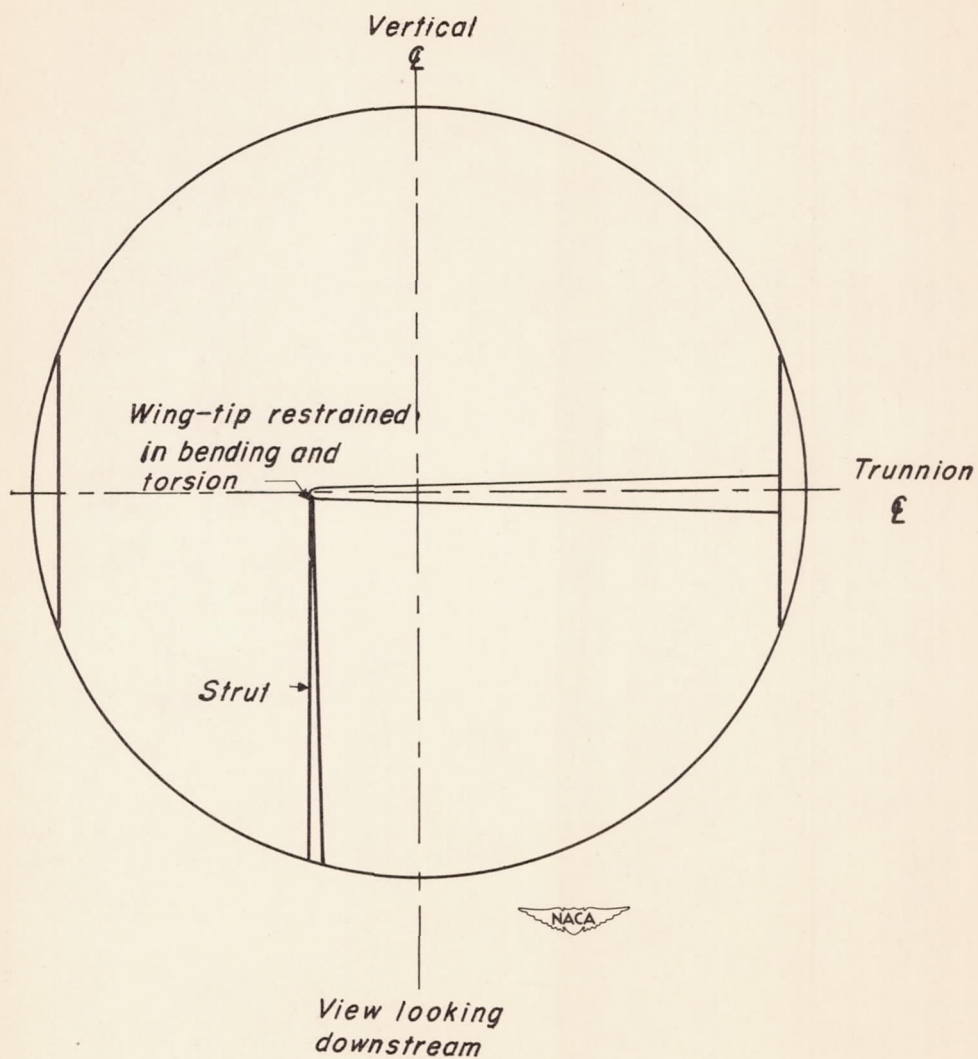
*Figure 9.—The partial-span wing mounted in the 16-foot high speed wind tunnel with tip fastened to strut.*

The boom was removed and the wing tip was fastened to a strut so that it was restrained in both bending and torsion. (See fig. 9.) Even this extreme change had no appreciable effect on the aileron flutter. The wing was not completely rigid during flutter although its motion was limited. (See table I, run 27.) Runs 5, 12, 22, 22A, and particularly runs 26 and 27, quite definitely proved that a new type flutter had been found - a type which required only one degree of mechanical motion.

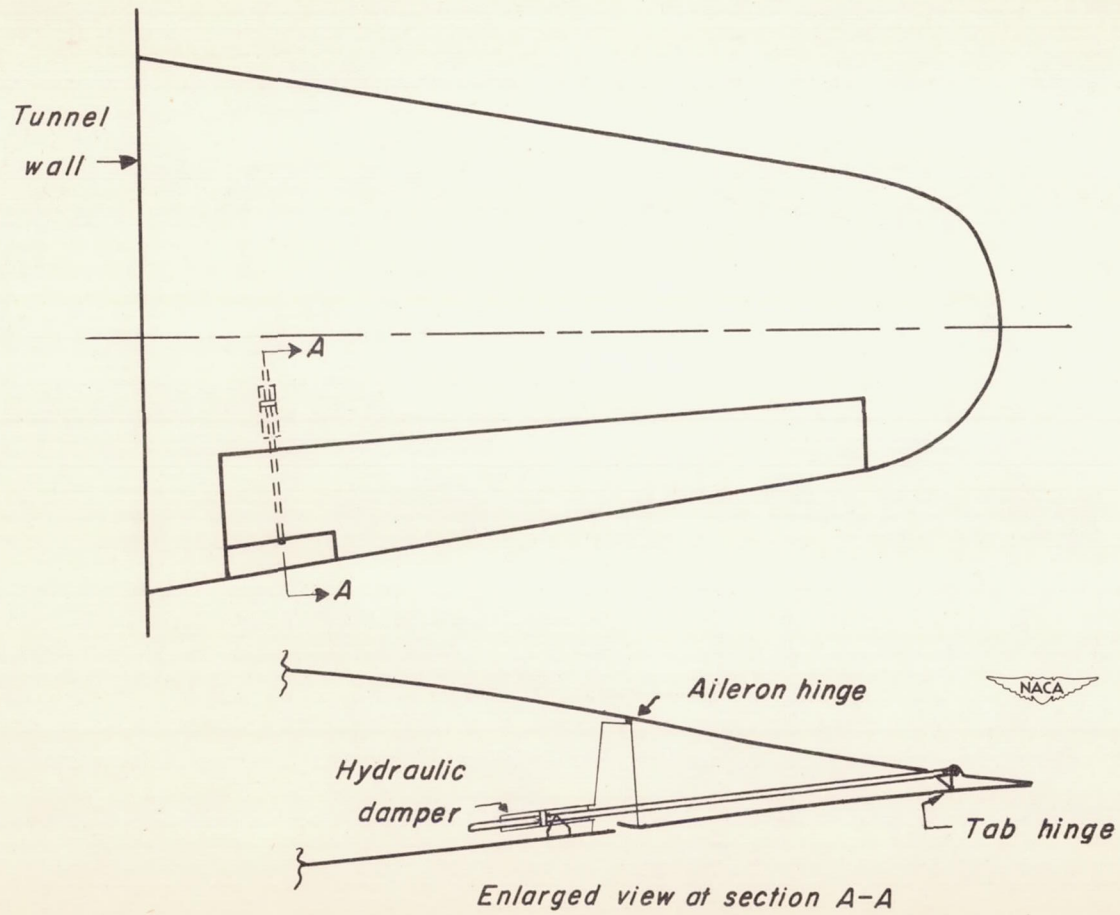
Figure 10.— Schematic drawing of antiservo tab with hydraulic damper.

In an effort to damp the flutter aerodynamically, an antiservo tab was installed on the aileron, as shown in figure 10. This tab floated freely during slow motion of the aileron, but it worked against the aileron during flutter because of the damping cylinder in the linkage. Its effect, however, was not sufficient to prevent flutter. (See table I, runs 28 to 31.)

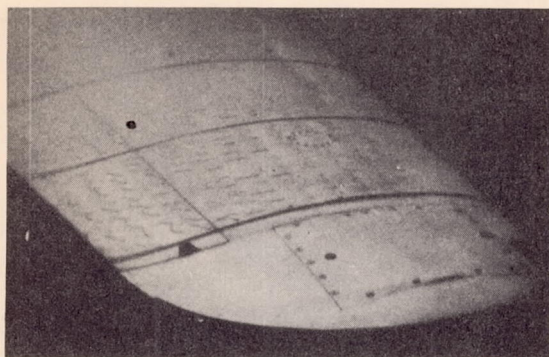
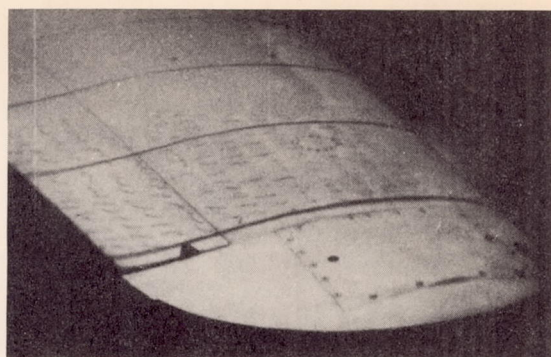
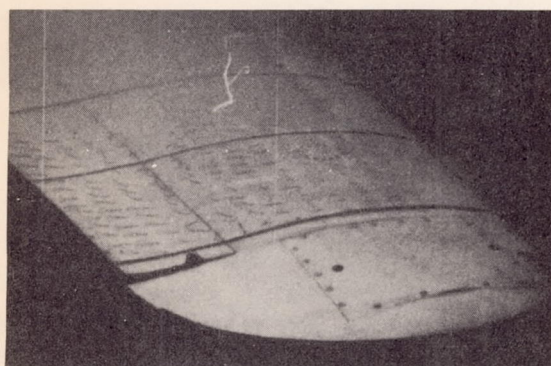
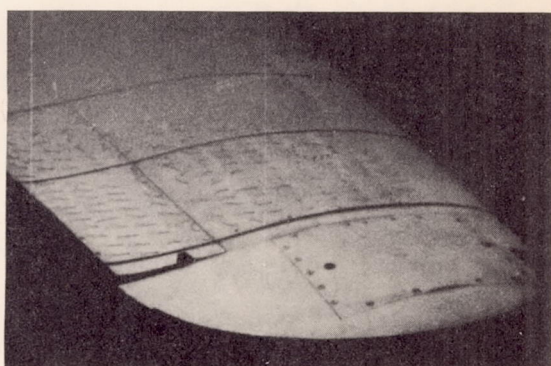
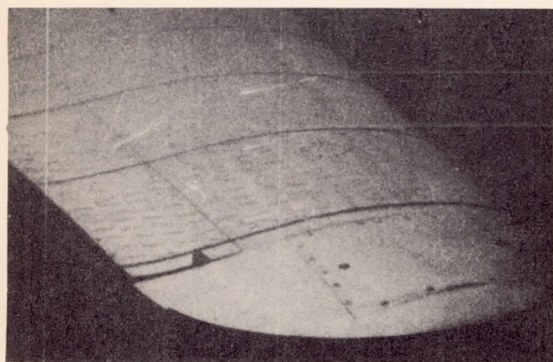
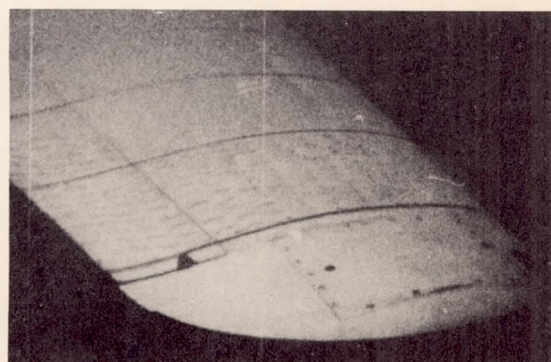
Figure 13.— Tuft studies on the partial-span wing showing change in flow separation for six aileron positions. Pictures are from a motion picture of the aileron flutter taken at 16 frames per second.

Motion pictures of tufts during flutter indicated separation on the aileron when it was approximately in its neutral position, with subsequent recovery when the aileron reached the maximum up-position. (See fig. 13.)

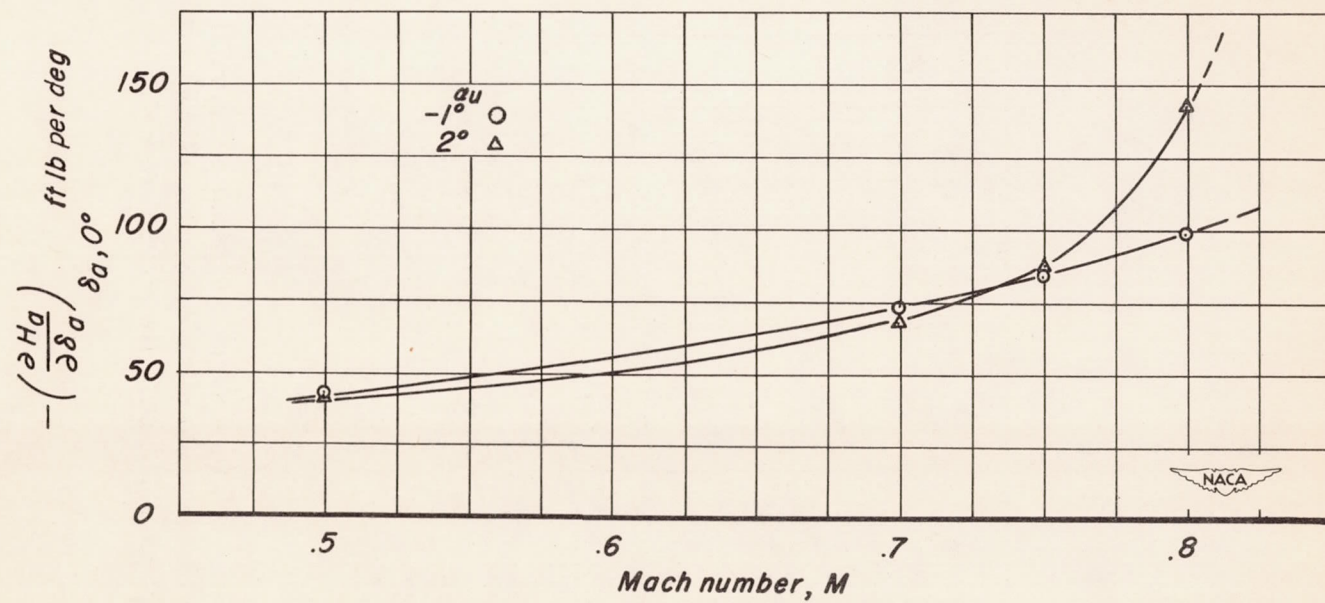
Figure 20.- Variation of aileron hinge-moment slope with Mach number at two angles of attack for the partial-span wing.  $\delta_a, 0^\circ$ .

reveals considerable increase in the slope  $\left[ -\left( \frac{\partial H_a}{\partial \delta_a} \right)_{\delta_a, 0^\circ} \right]$  at

Mach numbers above 0.74 as the angle of attack was changed from  $-1^\circ$  to  $2^\circ$ . The change in slope corresponds to about 25 foot-pounds per degree of aileron angle at the Mach numbers at which flutter occurred.

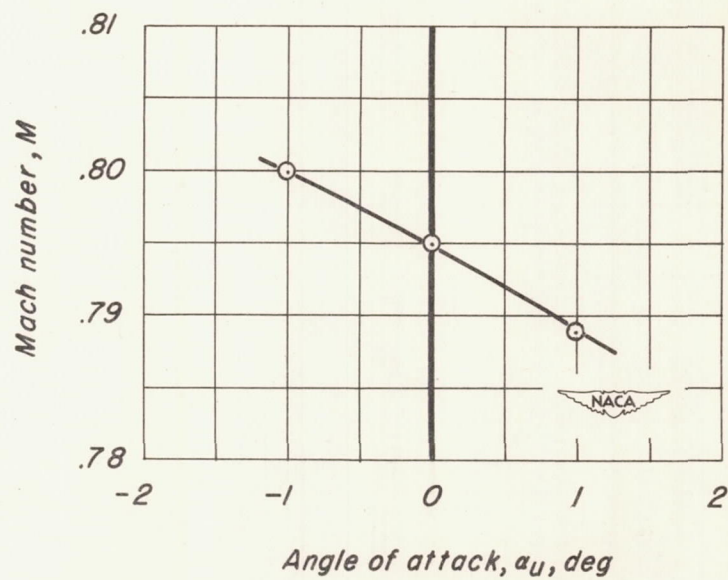
Figure 21.— Angles of attack and Mach numbers at which flutter occurred during tests of the partial-span wing with the aileron free.

Figure 21 shows the Mach number at which flutter started at three angles of attack, indicating that the flutter was probably influenced by the local critical Mach number. (See table I, run 5.)

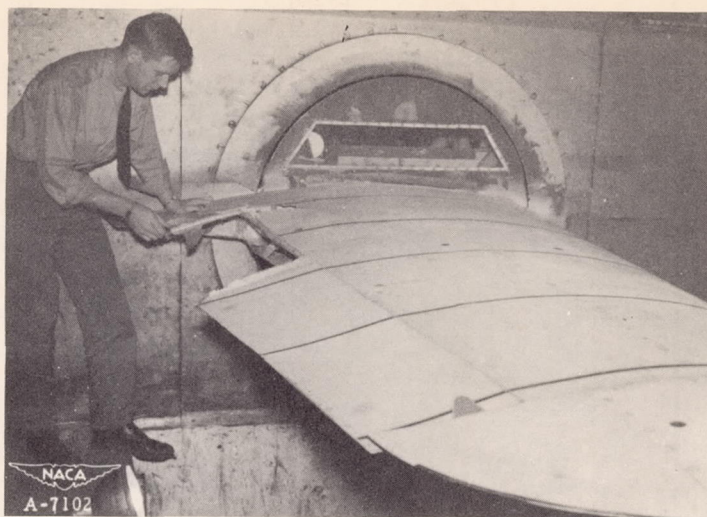
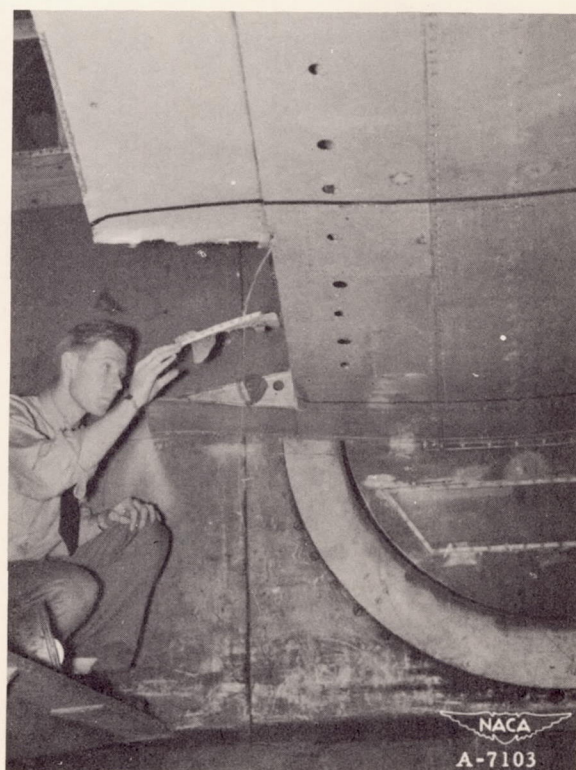
Figure 22.— Failure of the inboard end of the aileron on the partial-span wing.

The tests in the wind tunnel were terminated due to failure of the aileron. The results obtained are presented in this report.

| Run number | Changes to standard configuration <sup>1</sup> | Results | Flutter frequency (cps) |
|---|---|---|---|
| 33 | Eleven 1-1/4-inch-diameter holes in wing overhang on lower surface. Cables loose. | Flutter at $M = 0.791$ , $\alpha = 0^\circ$ . Part of aileron failed, ending investigation. | 21.6 to 24.0 |
